BA • 1 CANAL BANK RESTORATION

Reconstruction of Canal Walls and Stormwater Control Structure

City of Palm Coast, Florida

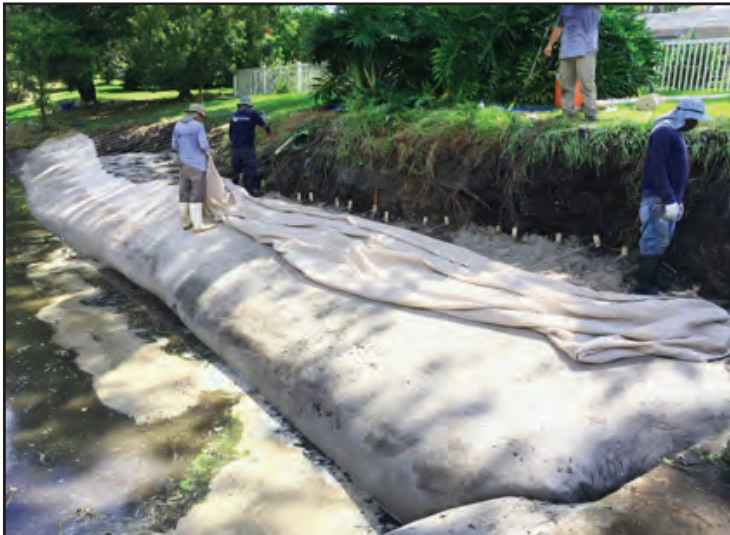
Using our amphibious work boat, we pump excess sediment from the canal to fill the SOX containment system.

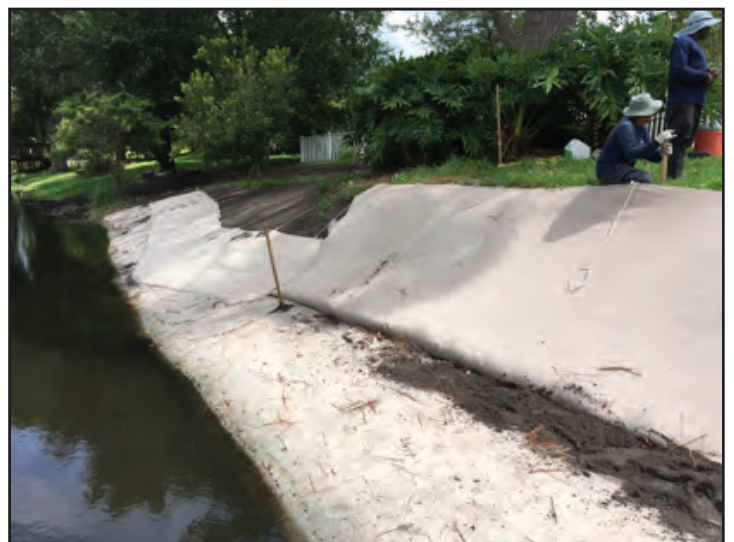
The second tier of the SOX is filled and all of the anchoring stakes are pounded sub surface.

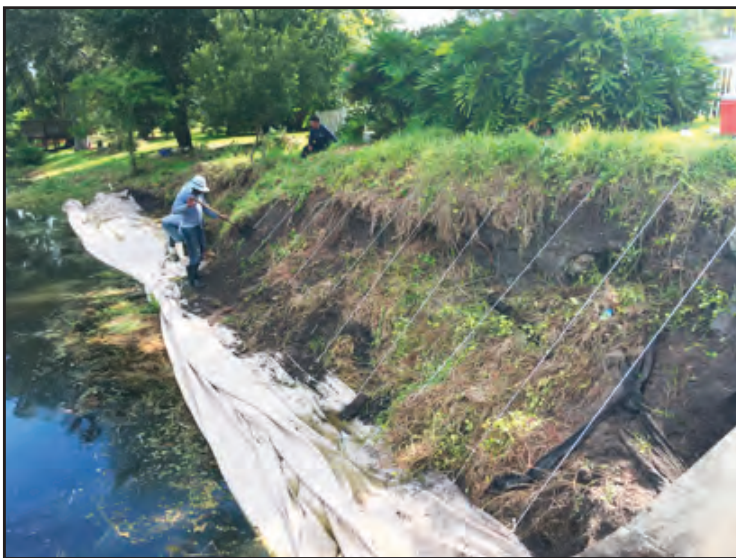
The SOX System is put into place while the canal bank is prepped and our patented anchoring and channeling system is secured to solid ground.

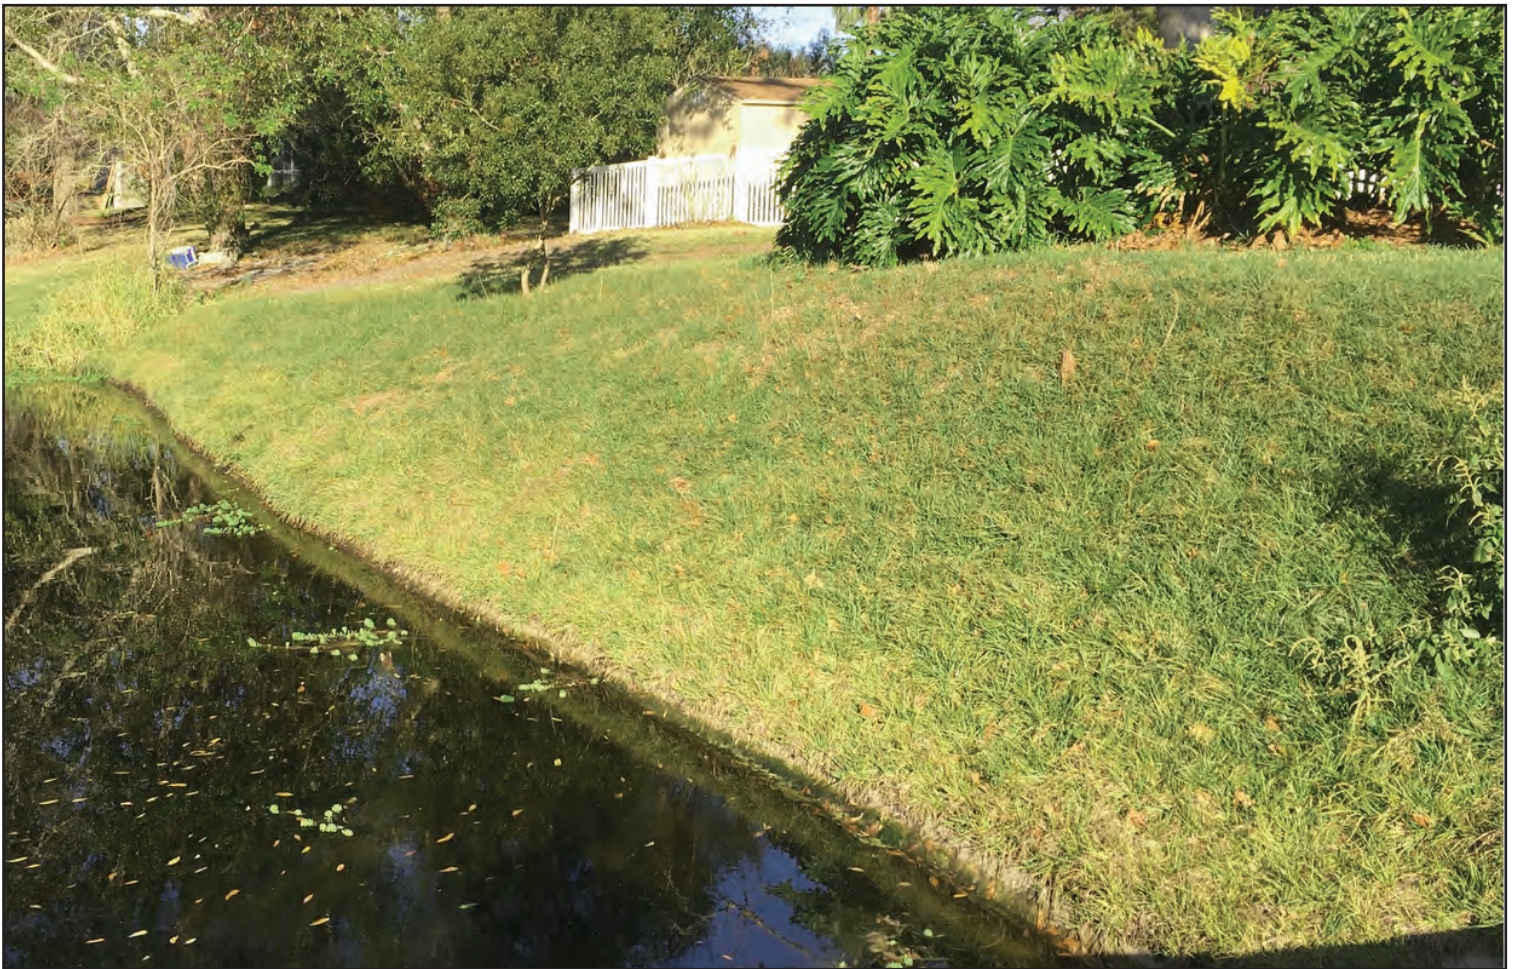
The sod is brought in and installed shortly after installation.
