2018 CASE STUDY

RESTORATION OF LAKE SHORELINE AT THE SEAGATE GOLF & C.C.

DELRAY BEACH, FLORIDA

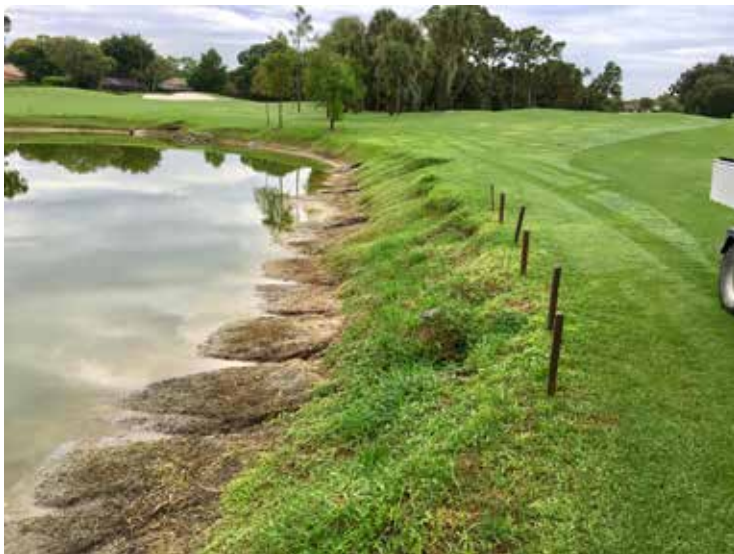
Severe erosion areas on the course began to pose a threat to the course itself and it's golfers.

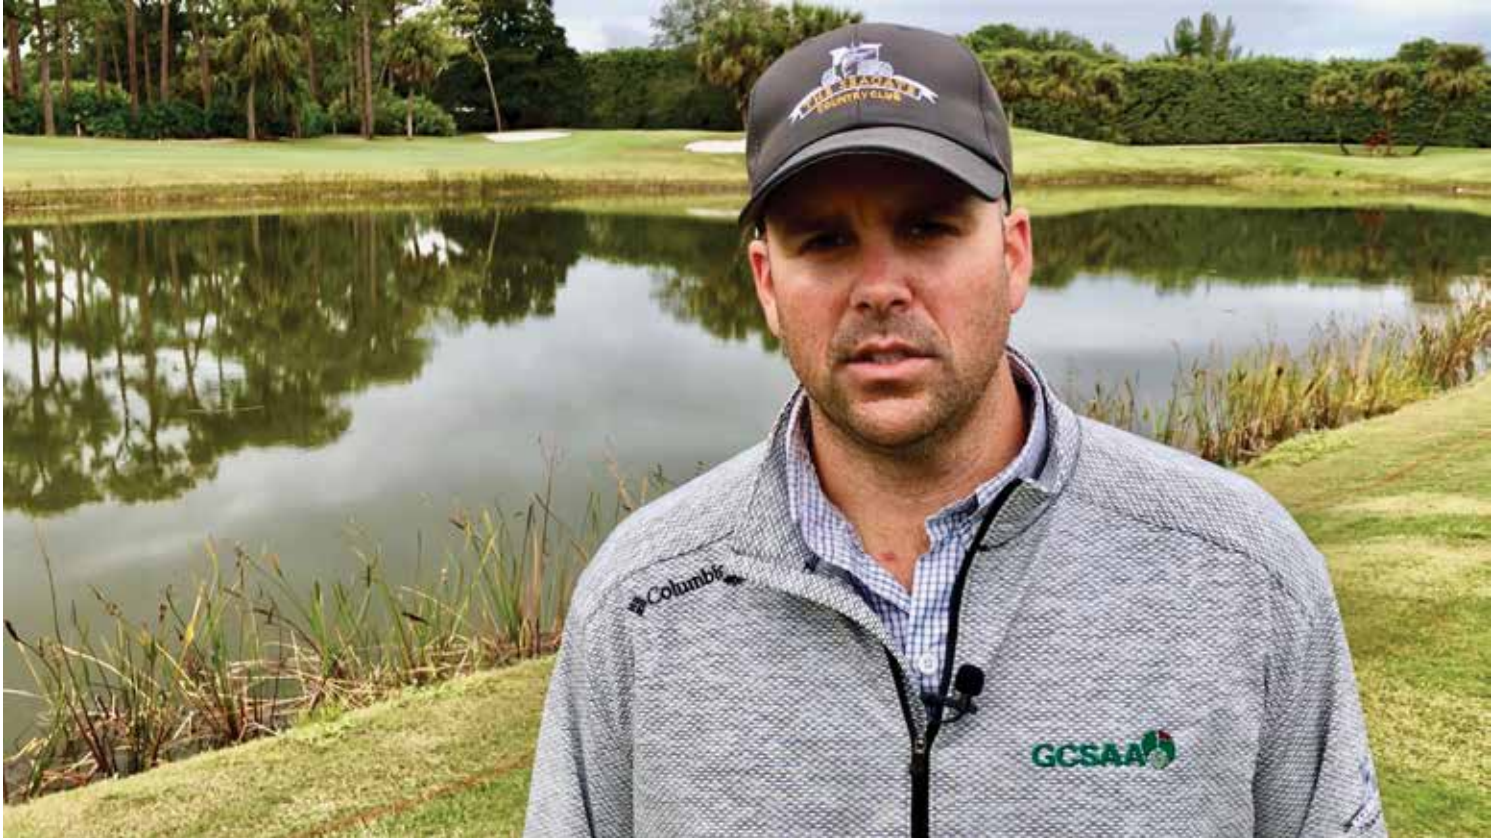
THE RESULT:

“It’s been two years since this lake shore has been restored using Dredgesox and I couldn’t be more pleased with the outcome,” says Nate Watkins, Superintendent of Golf Course and Grounds at Seagate Golf and Country Club.
